## Evaluation of Damage Problems in the Water Pump Components of an Air Compressor Cooling System: a Case Study

<sup>3</sup>National Iranian South Oil Company, Technical Inspection and Corrosion Metals Laboratory

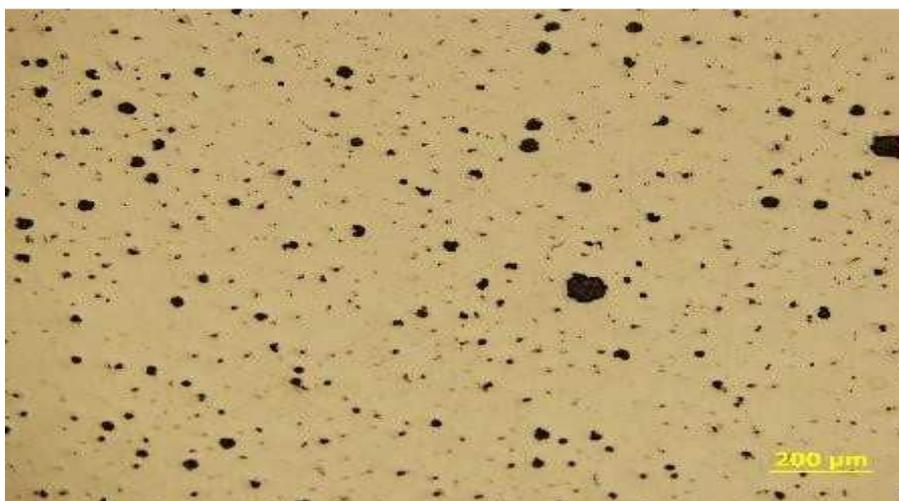
Examination of microstructure of metallographic samples showed that the pump casing has a uniform distribution of spherical graphite (Figure 2) and the pump impeller has a random distribution of graphite sheets in the field of ferrite – pearlite.(Figure 3, 4)

Figure2. Spherical graphite with almost uniform distribution of the sample metallographic taken from the pump body

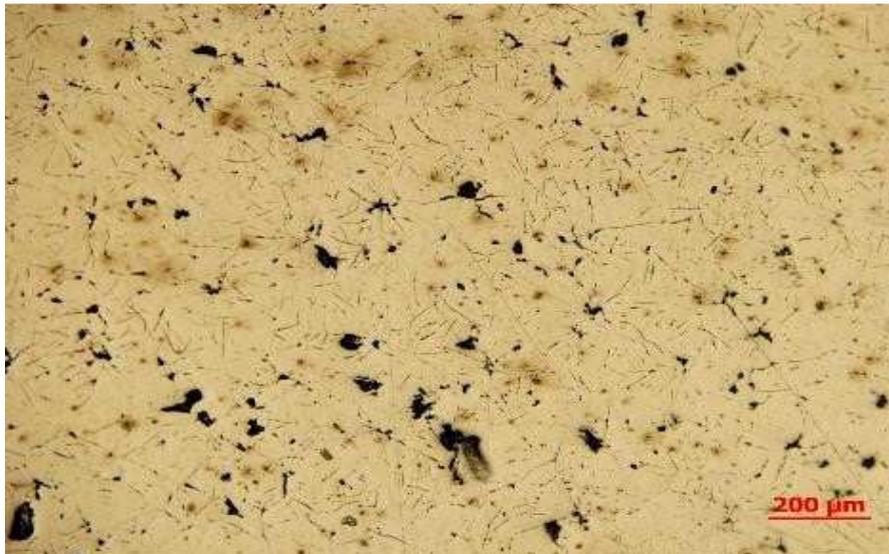
Figure3. Graphite of sheets representing grey cast iron used in the polished sample pump impeller

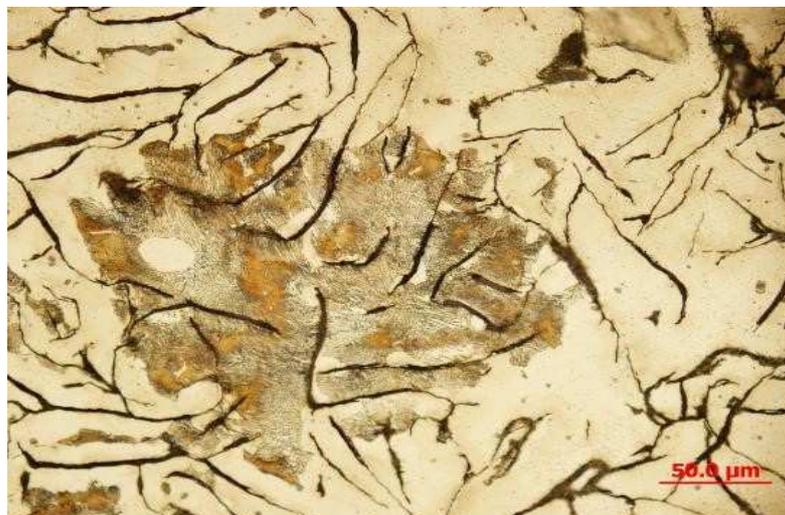
Figure4. Graphite sheets in sample ferrite-perlite structure taken from the pump impeller (affectation picral affectation)

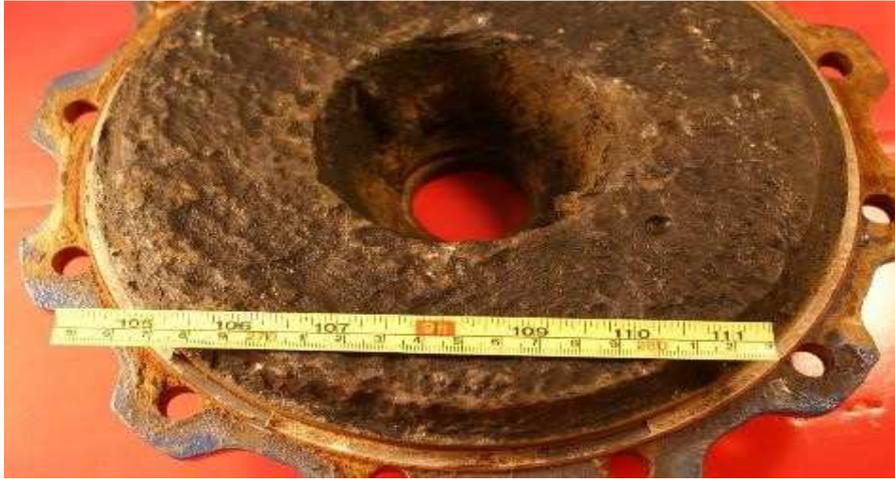
In some parts of the microstructure, porosity of the casting process also is observed to a limited extent. Severe corrosion along with thickness reduction is evident in some of the interior components of the pump.

In addition to reducing the thickness, sediment accumulation and corrosion products on the components are visible as shown in Figure. 5.

Figure5. Damage and the formation of deposits on the inner cover of the pump

The presence of corrosive factors such as chlorine ions in water used in the air compressor of the cooling system in which chemical analysis of the sediment and corrosion products also uncovers the role of these factors can be considered. It seems that in this regard, focusing more on quality of used water and adapting its characteristics to the conditions in manufacturer's instructions will be necessary.

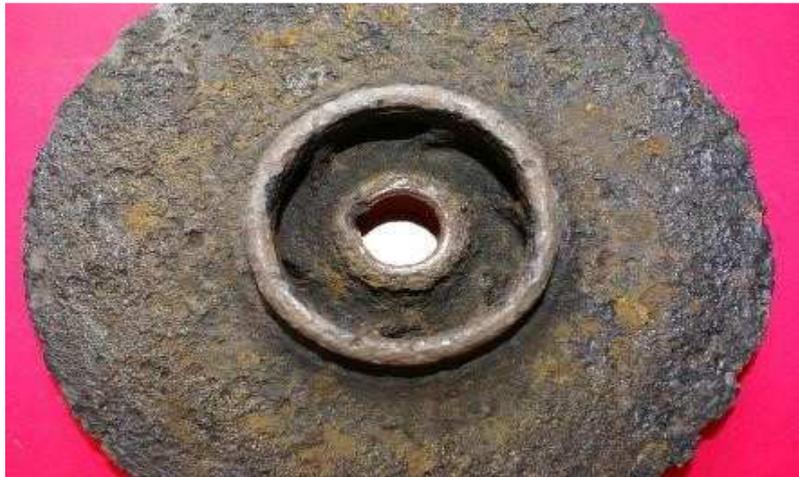
The damaged pump impeller is coated by black, brittle, fragile, and quite porous deposition. (Figure6)

Figure6. Corrosion and destruction of water pump impeller of the cooling system air compressor

According to studies, particularly considering the results of structural evaluation and chemical decomposing of the sediment, the type of impeller damage is graphite corrosion. Graphite corrosion is categorized as selective corrosion.

A solution that is often used to prevent corrosions such as graphite corrosion is proposed to replace the alloy. It is essential that the phenomena and damages such as selective separation occur due to specific metallurgical structure of some alloys. Therefore, by changing the conditions of this type of alloy, such damages will reduce probably. For example, replacing gray cast iron with other white cast iron reduces the risk of this phenomenon strongly. However, in terms of reducing, it is discussed with regard to significant corrosion in other system components. It is very important to conduct these strategies more carefully.

The white cast iron is very hard machining alloy and if this alloy be used, the cost of pump gets high. In general, white cast iron is used when erosion is important. But, when the corrosion is important, the alloy such as stainless steel is usually used (such as AISI 410, 420).

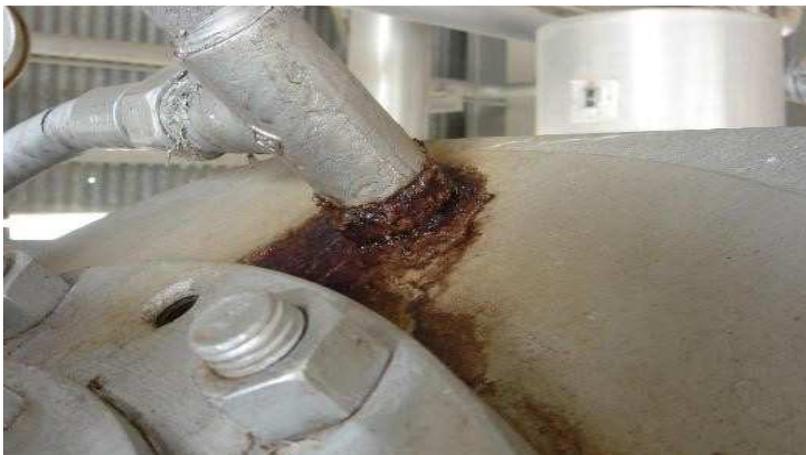
Due to the fact that cooling system alloy tubes are made of stainless steel, therefore corrosion in the pipes has to be seen significantly. Most fractures are gathering at the junction of the plain carbon where steel coating is used as shown in Figure 7.

Figure7. Corrosion at the junction of cooling water system to the compressor

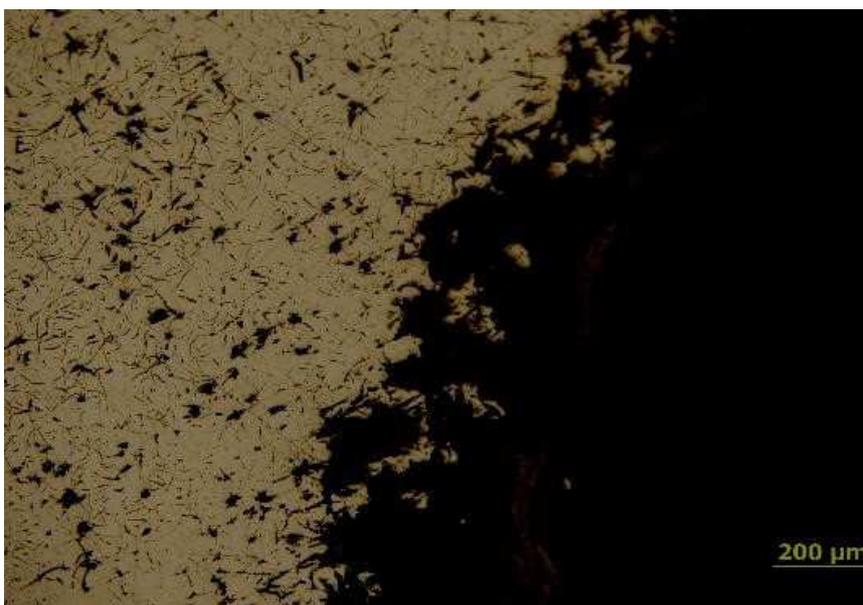
As shown in Figure.8, the collapse of the graphite cast iron grids and formation of black and porous layer and also formation of corrosion products that in some areas include up to half of the thickness of the sample is evident.

Figure8. Separation of cast iron from iron and leaving the black graphite layers on the surfaces of the pump impeller, when polishing the sample

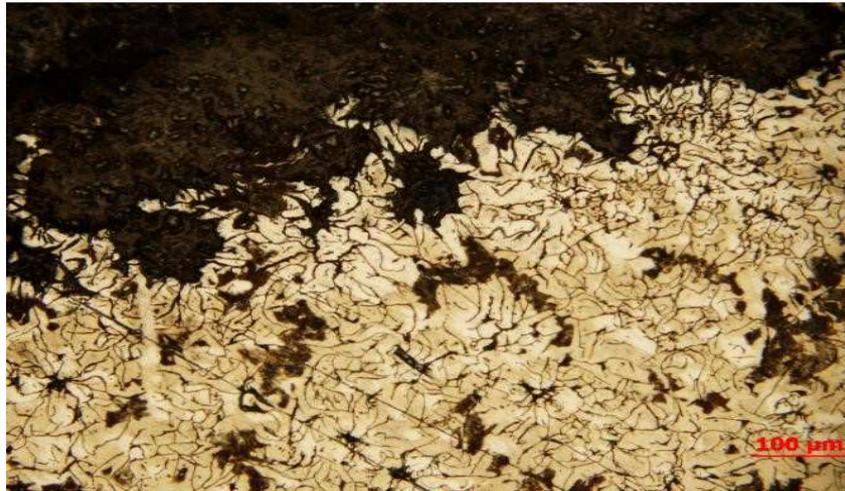
Figure9. Iron-free areas because of graphite corrosion

At the surfaces of the pump impeller, the intensification of corrosion at the contact point of the graphite with the ferrite – perlite network is discernable marked places.

The graphics in the gray cast iron compared with iron nets are less inclined to reaction. If the cast iron is in electrolyte, grid iron usually reacts in oxide or sulfide form (depending on the conditions of the fluid) and then is removed and leaves an iron-free and graphite-saturated network.
